Five-Fatality High-rise Office Building Fire Atlanta, Georgia

Five-Fatality High-rise Office Building Fire Atlanta, Georgia (June 30, 1989)

Investigated by: Charles Jennings

This is Report 033 of the Major Fires Investigation Project conducted by TriData Corporation under contract EMW-88-C-2649 to the United States Fire Administration, Federal Emergency Management Agency.

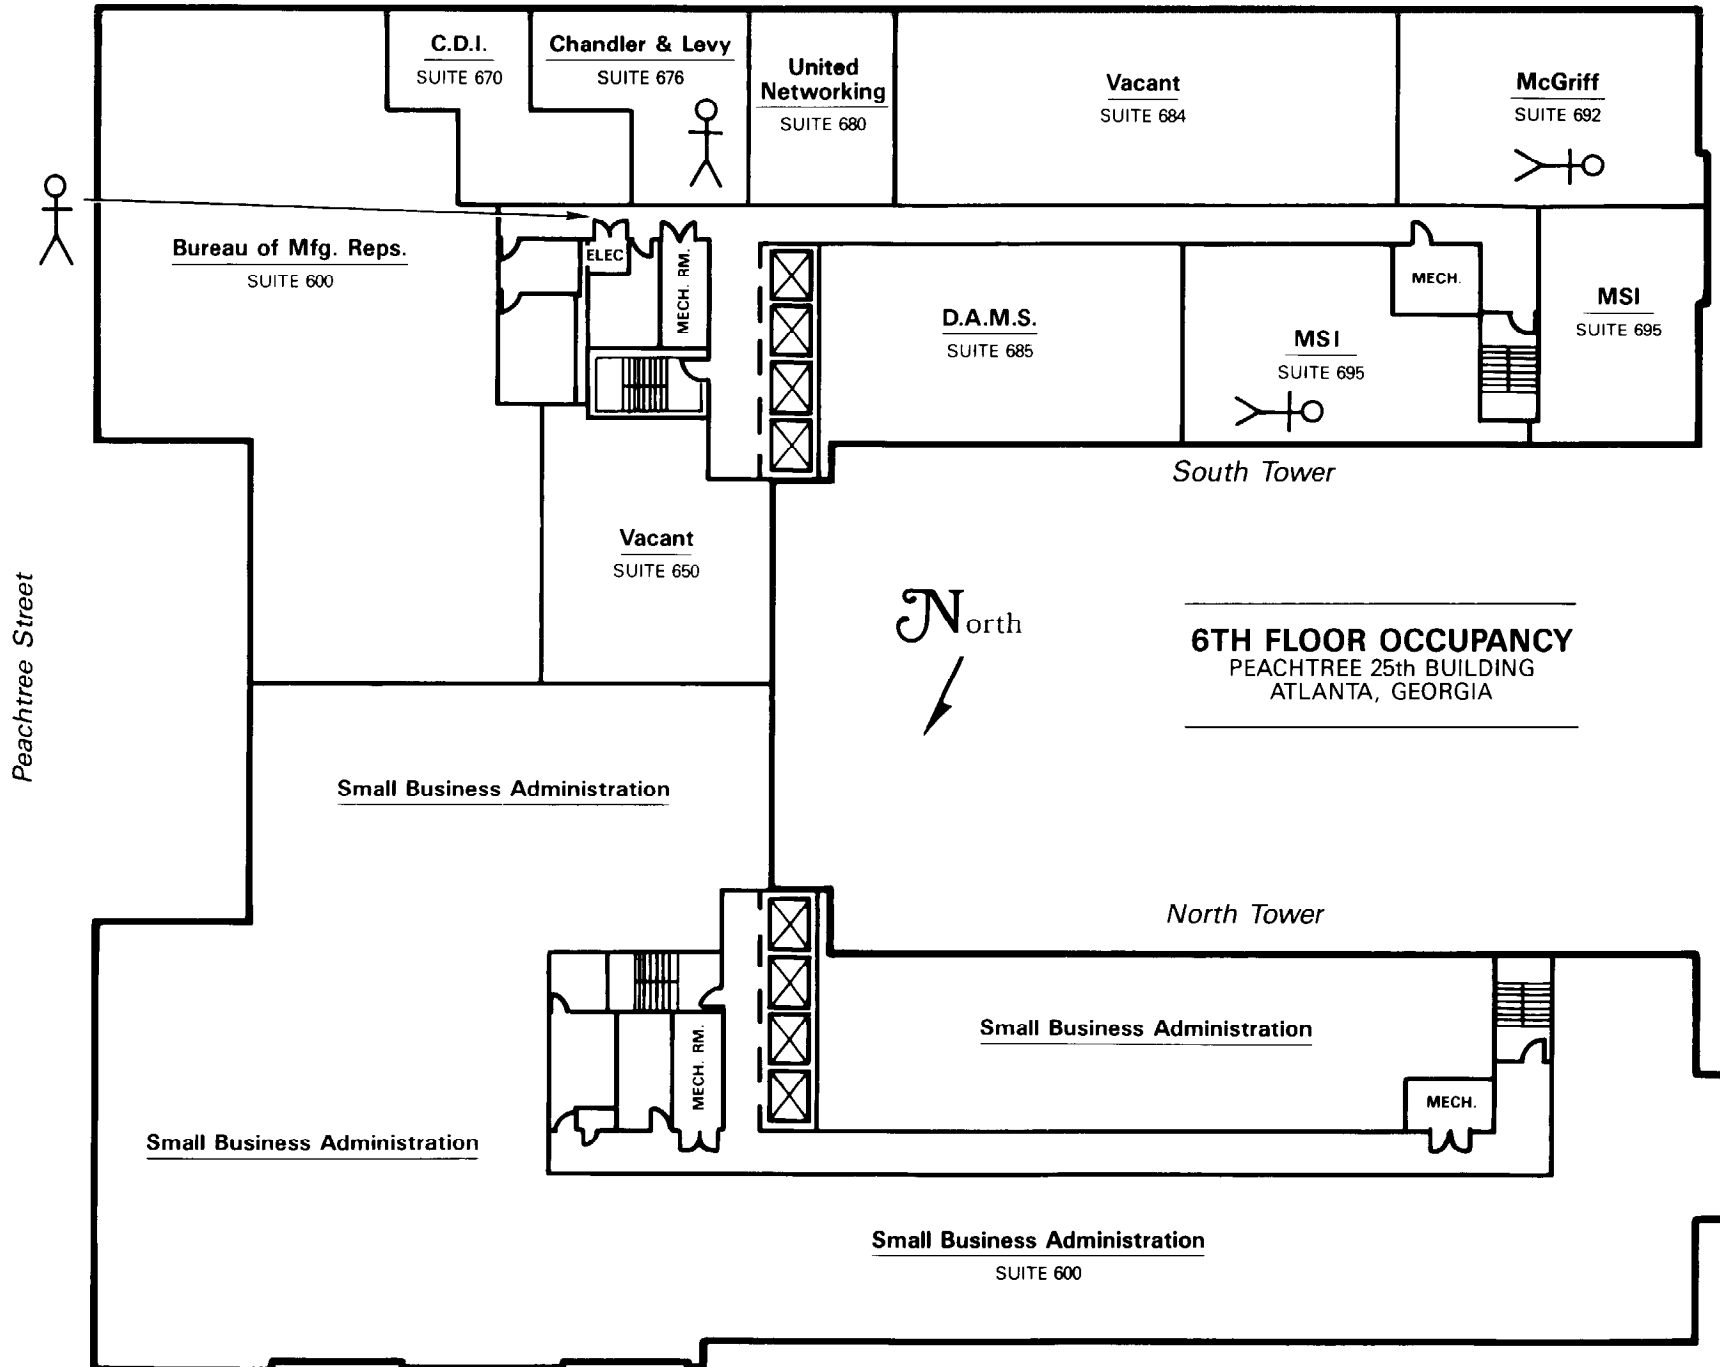
APPENDIX B

South Towers on the corridor serving the elevator lobbies (see Appendix B). On the sixth floor, where the fire started, there was no connection between the North and South Towers. In all cases, there was no separation of elevator lobbies from the corridor.
